CAT GIRDLE INFORMATION.

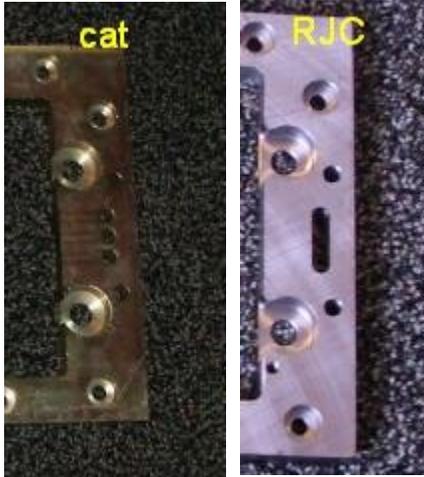
#1 DESIGN FLAW:

This is an exact duplicate of my Revision A girdles that i made when nearly a decade ago when we first developed them. These girdles had an inherent flaw in the design that caused them to leak oil. This is what attributed to reputation that girdles leak oil. The crank throw windows were much smaller to add as much "beef" to the girdle as possible.

Although that sounds good on paper it causes the girdle to extend into crank area creating a lip for the oil spray off of the crank to hit. This feeds the oil directly into the seams between the pan rail portion of the block and the girdle and seam between the girdle and the oil pan. This makes it extremely difficult to get them to seal up and not leak oil. Luckily we only sold a few of these before we realized the problem.

We offered to re-machine these girdles to all of our customers free of charge. The machine work to fix them is expensive but at the time we had so few of them in the field we were able to absorb this cost. At the rate a select few of the distributors are selling them it will be very expensive problem. This design flaw also makes it so the RJC crank scraper absolutely will not work. Since RJC addressed this problem we do not have any issues related to this problem area.

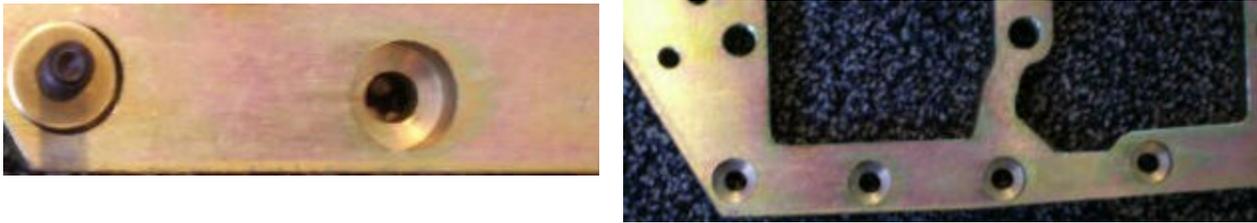
#3 PANRAIL HOLES;

The pan rail holes in the girdle were not in the correct location. We had to slot 8 of the 20 holes to get it to fit a standard Buick 20 bolt block. Once we slotted the hole we could install the girdle but now the counter bore was off from our newly slotted hole enough that we could not use the sealing washers. This took us more than an hour just to get the girdle to fit onto the block. This is just plain unacceptable quality.

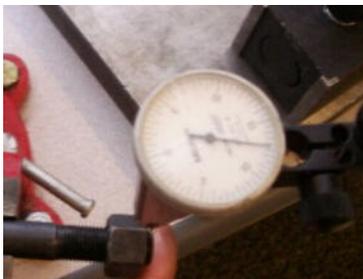
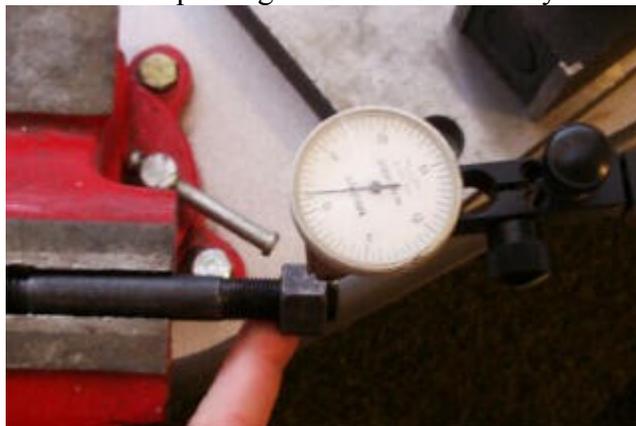
#4 FASTENERS;

All of the studs are of typical Chinese quality. Nothing ARP here. The thread on the nuts and studs are out of tolerance even if checking to the loosest lowest standard ANSI UN thread tolerances) on the nuts and studs you can see this "slop" just by feeling the difference between the nut and the stud after spinning one of the main nuts on. Shown below in the pictures is the combined result of the poor quality main nut and main stud. We measured close to .015 of slop between the two. This is a huge amount considering how fine the threads are. Even the stock bolts are a much better fastener than these studs. These studs did hold the required 100 ft/lbs of torque but there is significant more load on the fasteners when the engine is running and the crank is spinning some RPM. Will they hold? Only time will tell.
